**THE MID-AIR COLLISION IN WASHINGTON, D.C. -- REFLECTIONS ON CAUSAL  
FACTORS OF AN AVIATION DISASTER**

**By: Alan Armstrong\***

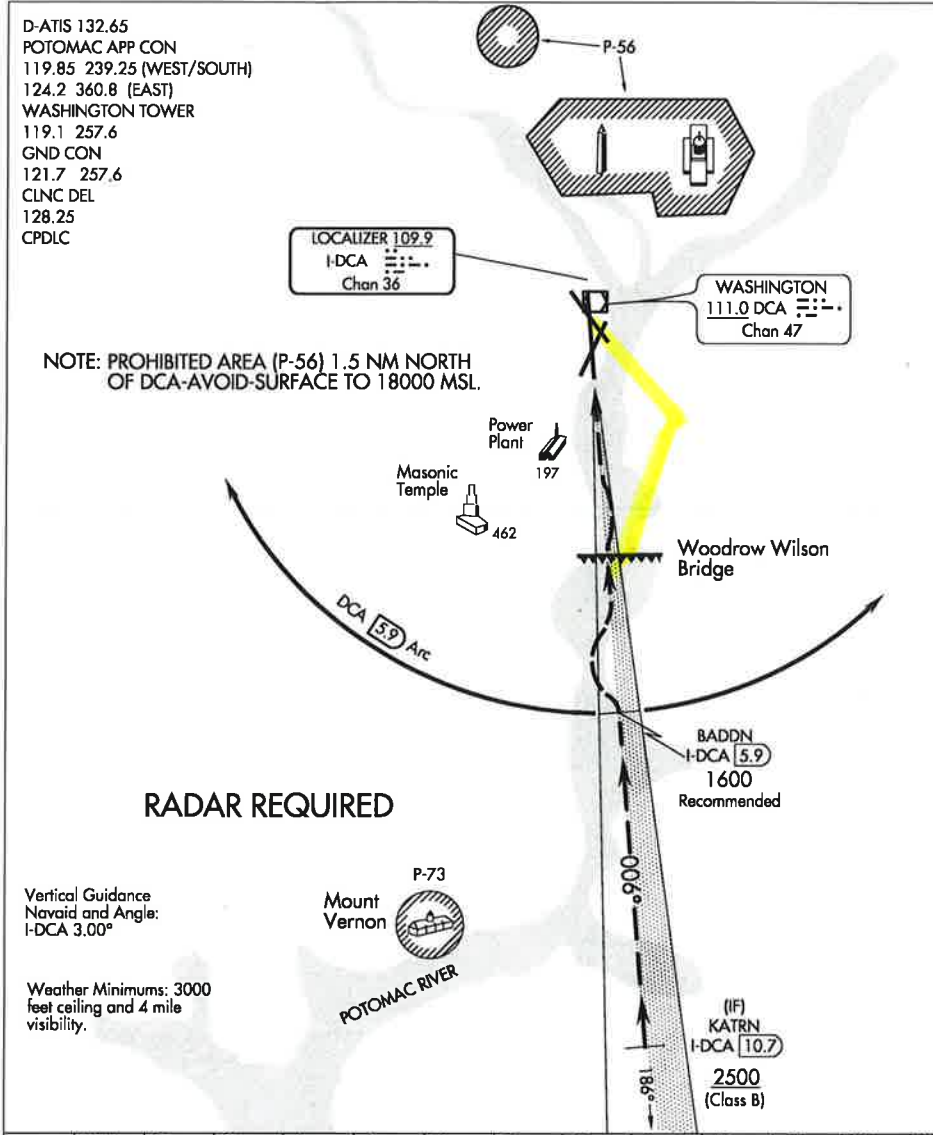
# MOUNT VERNON VISUAL RUNWAY 1

At 20:39:10 E.S.T. Potomac Approach cleared BlueStreak 5342 for the Visual Approach to Runway 01 at the Washington National Airport. To orient the reader, appended to this article as Exhibit 1 is the Mount Vernon Visual Runway 01 Approach with the BADDN intersection 5.9 nautical miles to the south of the airport. A visual checkpoint is the Woodrow Wilson Bridge to the south of the airport. Note the weather minima for the approach require at least a 3,000-foot ceiling with at least 4 miles of visibility. The vertical guidance for descent is a 3-degree glideslope.

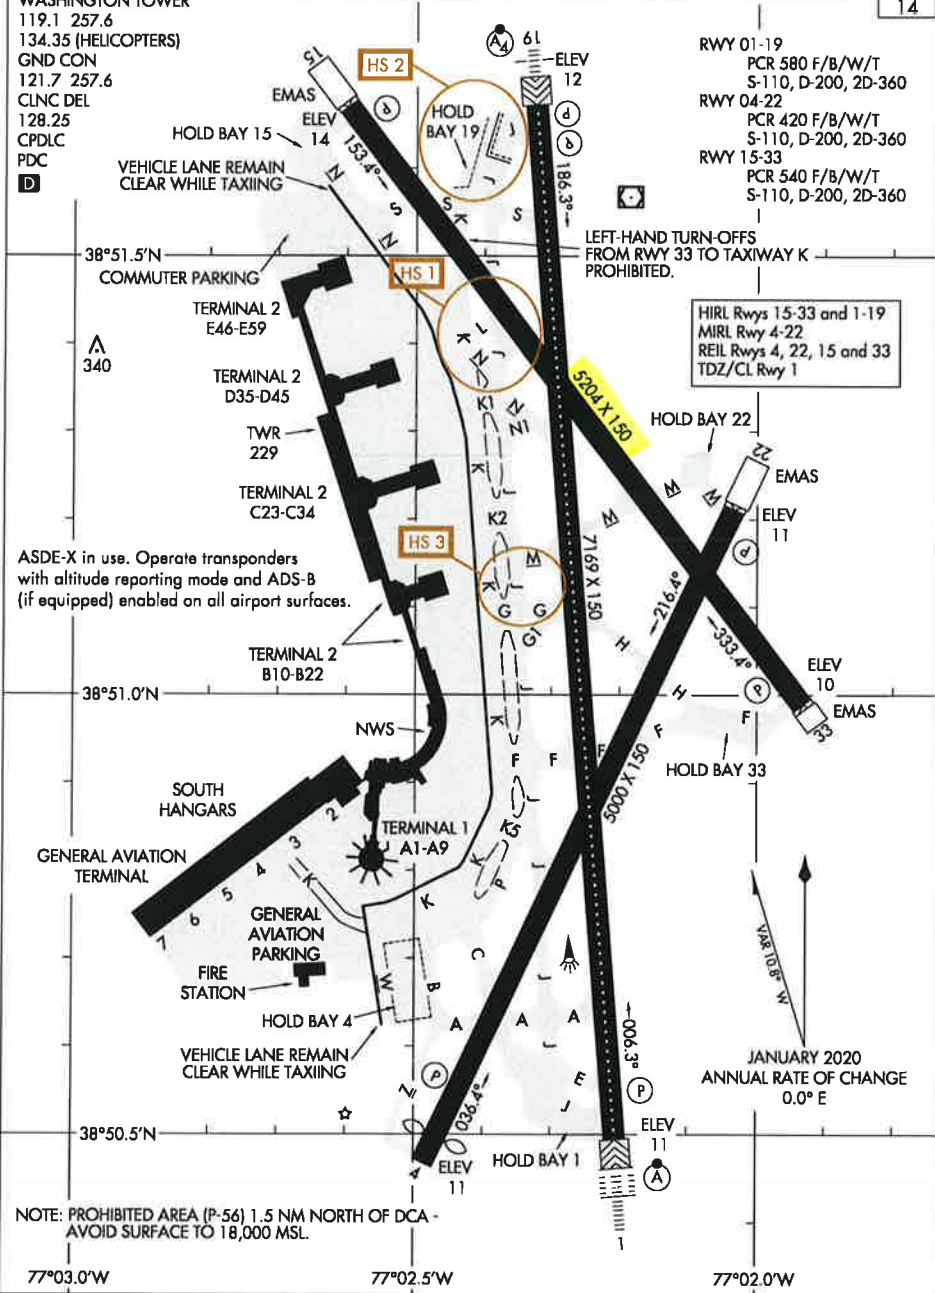
# AIRPORT DIAGRAM

After BlueStreak 5342 was handed over to the Washington National Control Tower, the local controller asked if the flight crew could accept Runway 33. The local controller was anxious to depart an American Airlines flight on Runway 01. The flight crew of BlueStreak 5342 agreed to accept Runway 33 for landing. Exhibit 2 to this article is an airport diagram confirming that the Landing Distance Available for Runway 33 is only about 5,200 feet which is not a long runway on which to land a transport category jet aircraft. This meant that the flight crew of BlueStreak 5342 would be busy on their landing approach, since a right turn to the northeast would be followed by a left turn to the northwest. The pilot flying would be busy monitoring his airspeed, altitude, and rate of descent while the pilot not flying would be focused on visually acquiring the runway environment to ensure the aircraft got lined up with the runway. These factors made the prospects of the CRJ crew visually acquiring the Army helicopter approaching from the north unlikely.

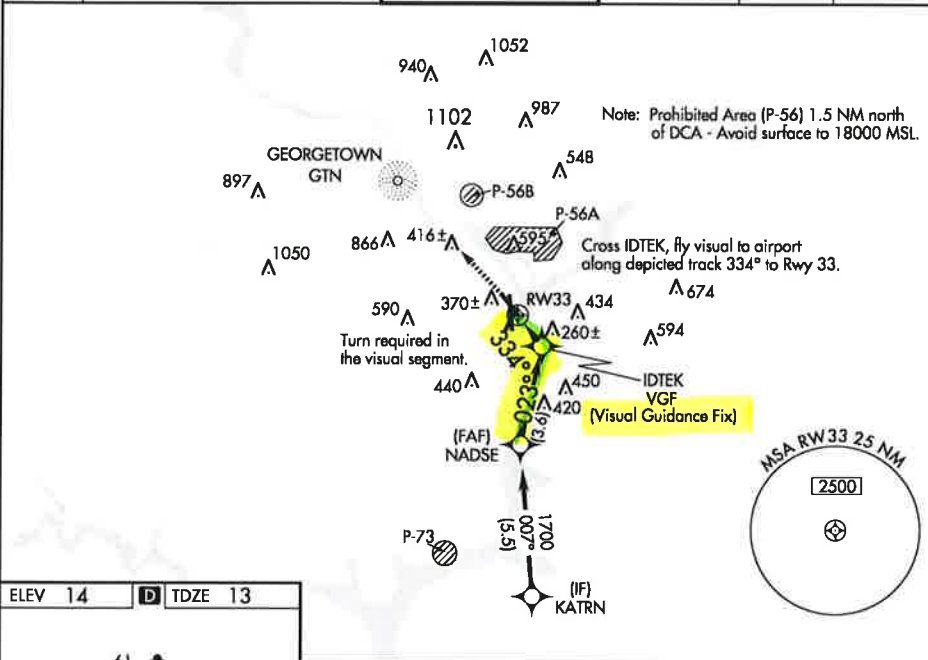
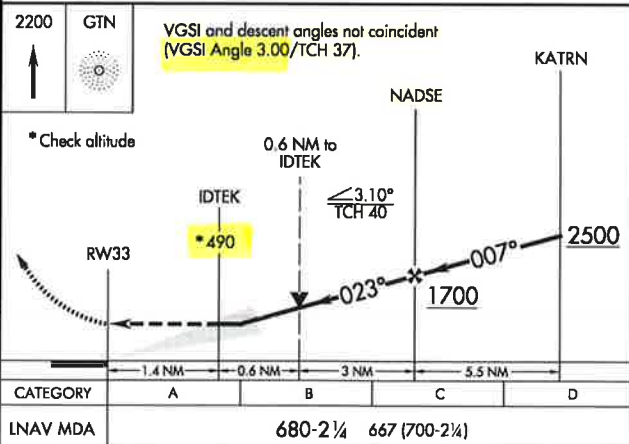
# RNAV (GPS) RWY 33

Because of the complex nature of the approach which is effectively a circle-to-land maneuver at night over water with no natural horizon, there is every reason to expect that the flight crew of BlueSteak 5342 would have loaded the RNAV/GPS Runway 33 Instrument Approach Procedure [Exhibit 3] into the aircraft's navigation system. Doing so would have increased the precision with which the aircraft would have been flown during the approach. It would have ensured a stabilized approach was flown, placing the aircraft over the IDEK instrument approach waypoint at 490 feet above ground level on a magnetic heading of 334 degrees toward Runway 33.

Third, according to the NTSB, the collision altitude between the aircraft was 325 feet, +/- 25 feet. Appended as Exhibit 4 to this article is a Washington, D.C. VFR Flight Route Map for helicopters confirming the maximum altitude at which PAT 25 was to have been flown was 200 feet. Operating a helicopter at 300 feet approximately one mile from the runway put the helicopter in the “kill zone.” This is true because the jet was flying a 3-degree glideslope, and one mile from the runway places the jet at an altitude of 300 feet above ground level. Some appreciation for the relative flight path of BlueStreak 5342 can also be found in Exhibit 3 attached, the Instrument Approach Procedure for the RNAV/GPS Runway 33 Approach. The approach confirms that the visual guidance system approach angle is a 3-degree glideslope. It further indicates that at 1.4 nautical miles from the threshold of Runway 33, BlueStreak 5342 would be at 490 feet above

ground level and would descend as it approached the runway. Additionally, as noted earlier, although this is speculation, it would have been a good practice and procedure to load the RNAV/GPS Runway 33 Instrument Approach Procedure into the navigation system of the Regional Jet. This would have assisted the flight crew in positioning the aircraft for landing and provided precise vertical and lateral guidance to Runway 33.

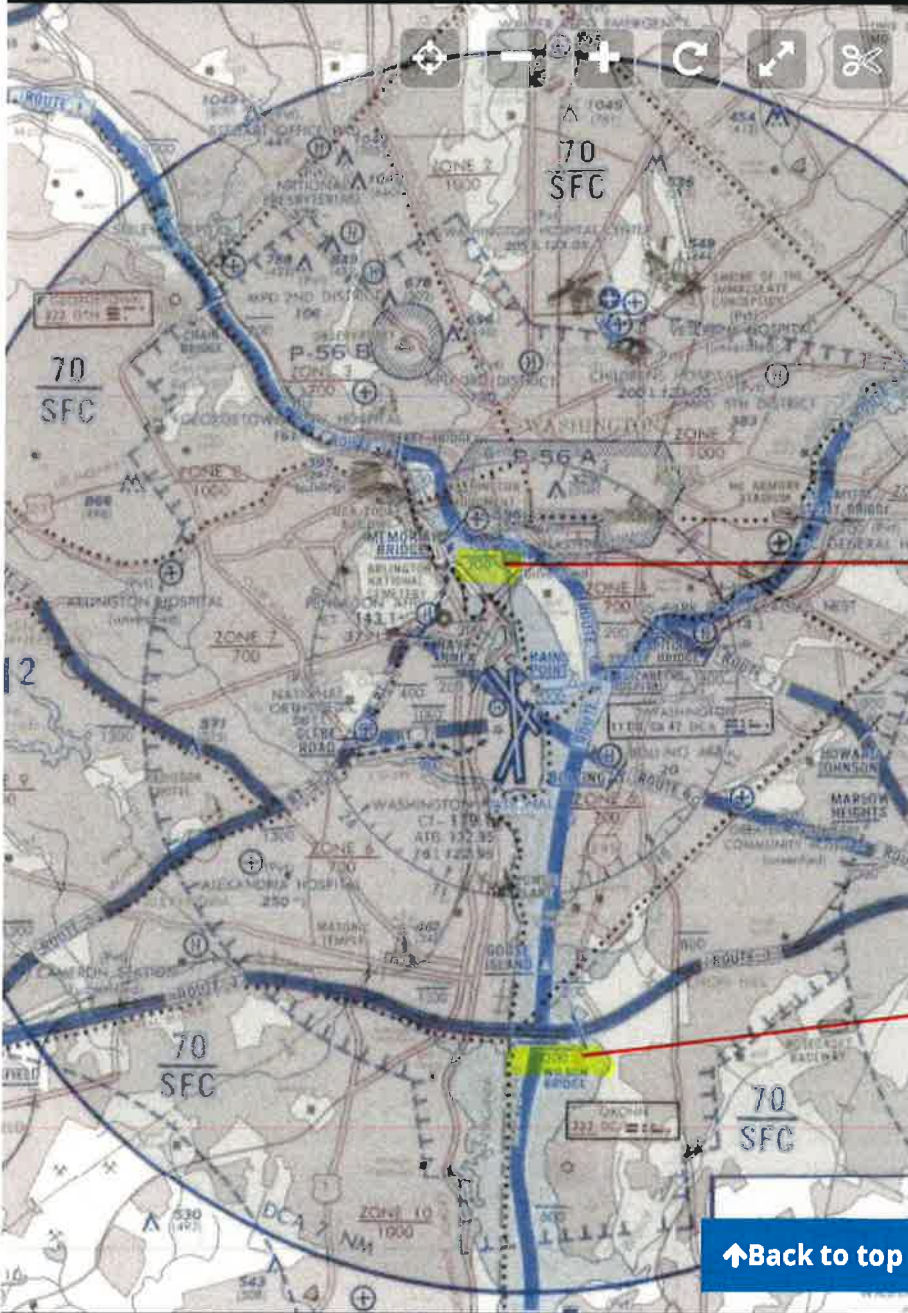
Blumberg, Inc. 5208  
**EXHIBIT**  
**4**

2. Operating a helicopter at 325 feet approximately one mile from a runway placed the helicopter in the "kill zone." Basic geometry indicates that if a transport category aircraft is one mile from the runway and following a 3-degree glideslope, the aircraft will be at an altitude of 300 feet above ground level. One would have expected that the Army flight crew was aware of this.
