FLIGHT-WATCH

GETTING THE KATE READY FOR THE 2014 AIR SHOW SEASON

An Ambitious Condition Inspection

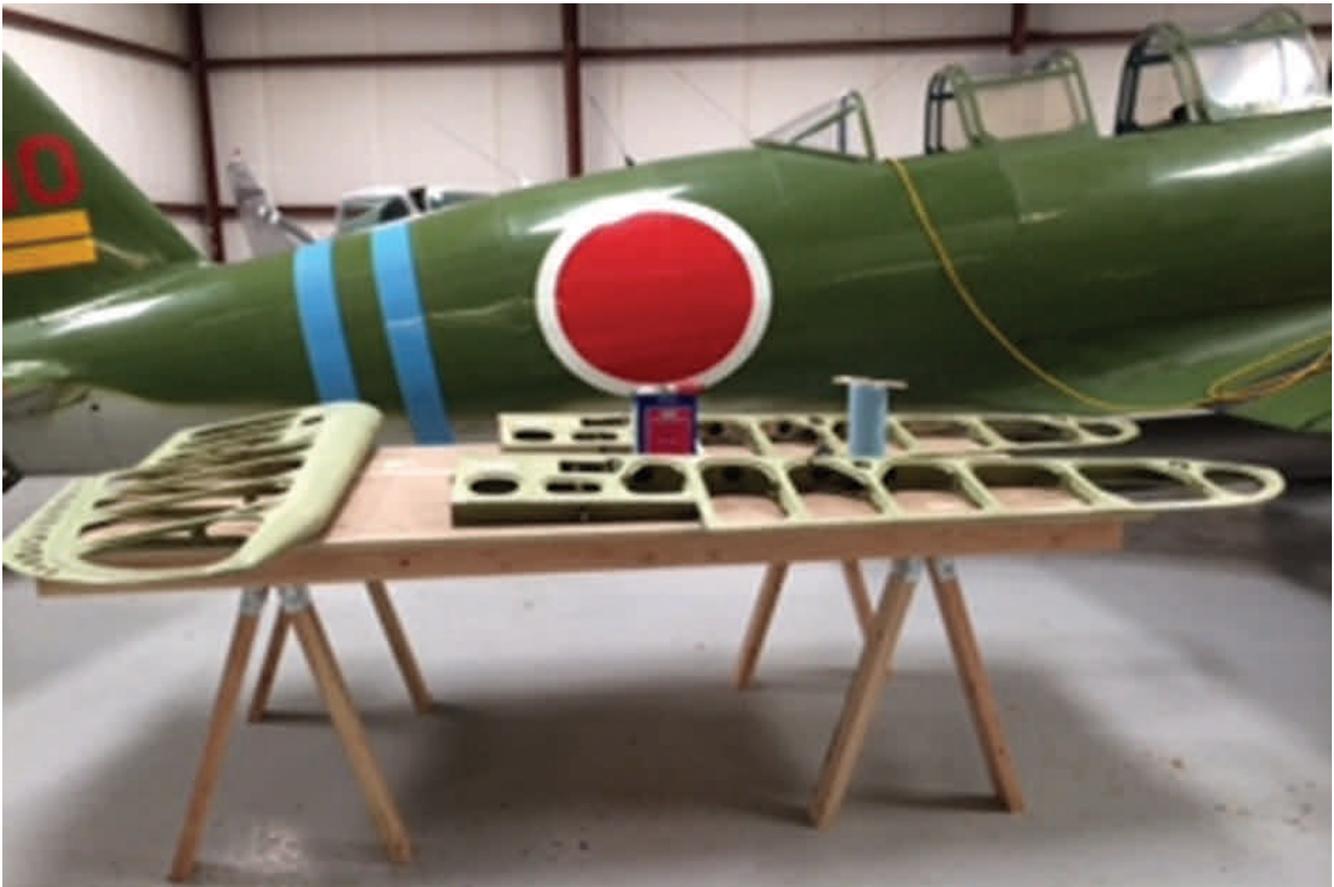
Last year, the Kate's condition inspection ran from February until sometime in the summer because the condition inspection became more of an IRAN (inspect and repair as necessary). Last year, we identified problems with the covering on the control surfaces that had begun to crack due to a dissimilarity between the dope on the control surfaces and the enamel paint. We tried, unsuccessfully, to remedy this by partially removing some of the enamel, and repainting the control surfaces. However, the cracks in the paint on control surfaces returned.

The Kate is presently down for another condition inspection. Generally, we found nothing of concern in the aircraft, but the control surfaces have now been removed, stripped, painted, and are being prepared for recovering.

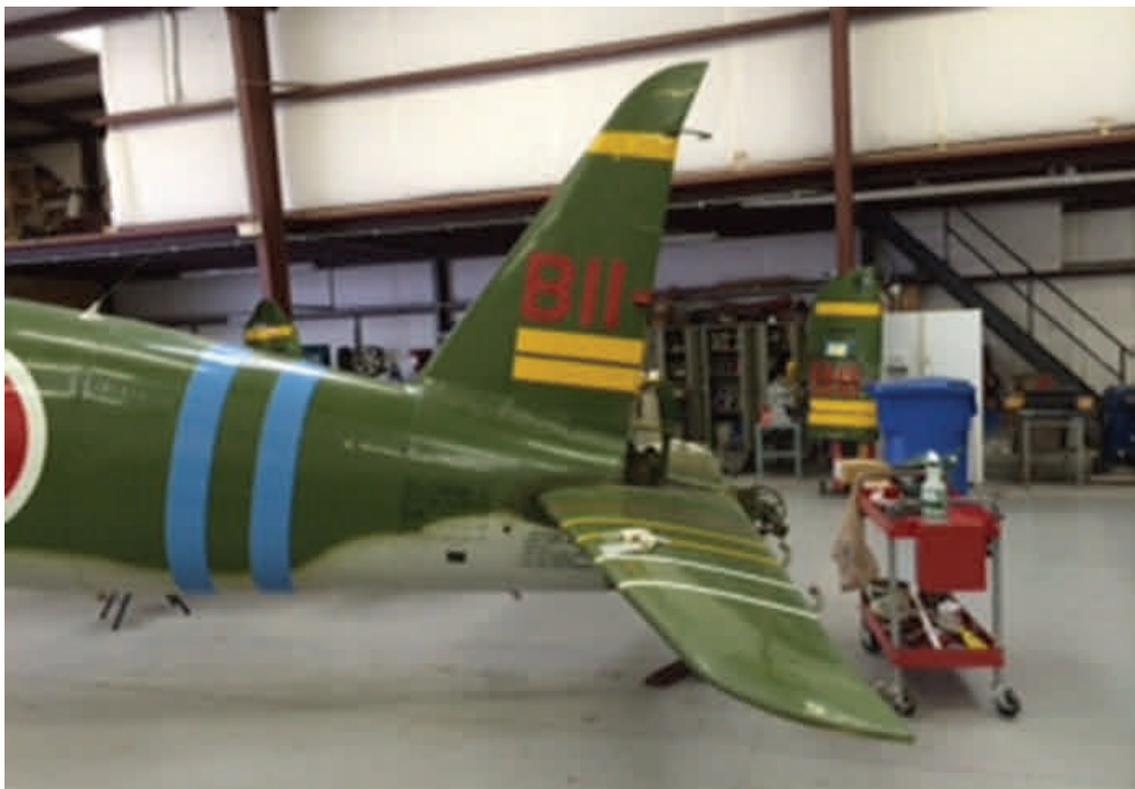
Chafing tape has been installed on the trailing edges and around various aspects of the control surfaces so that when the fabric is applied, it will not crack or have stress areas that would lead to cracking of the dope and paint. Apparently, in World War II, instead of using chafing tape, they just used masking tape.

After the flight controls are covered, they will receive two coats of brushed on dope followed by several coats of sprayed on dope. Eventually, the enamel will be painted on the control surfaces by Buck Roetman at his paint booth in Macon, Georgia.

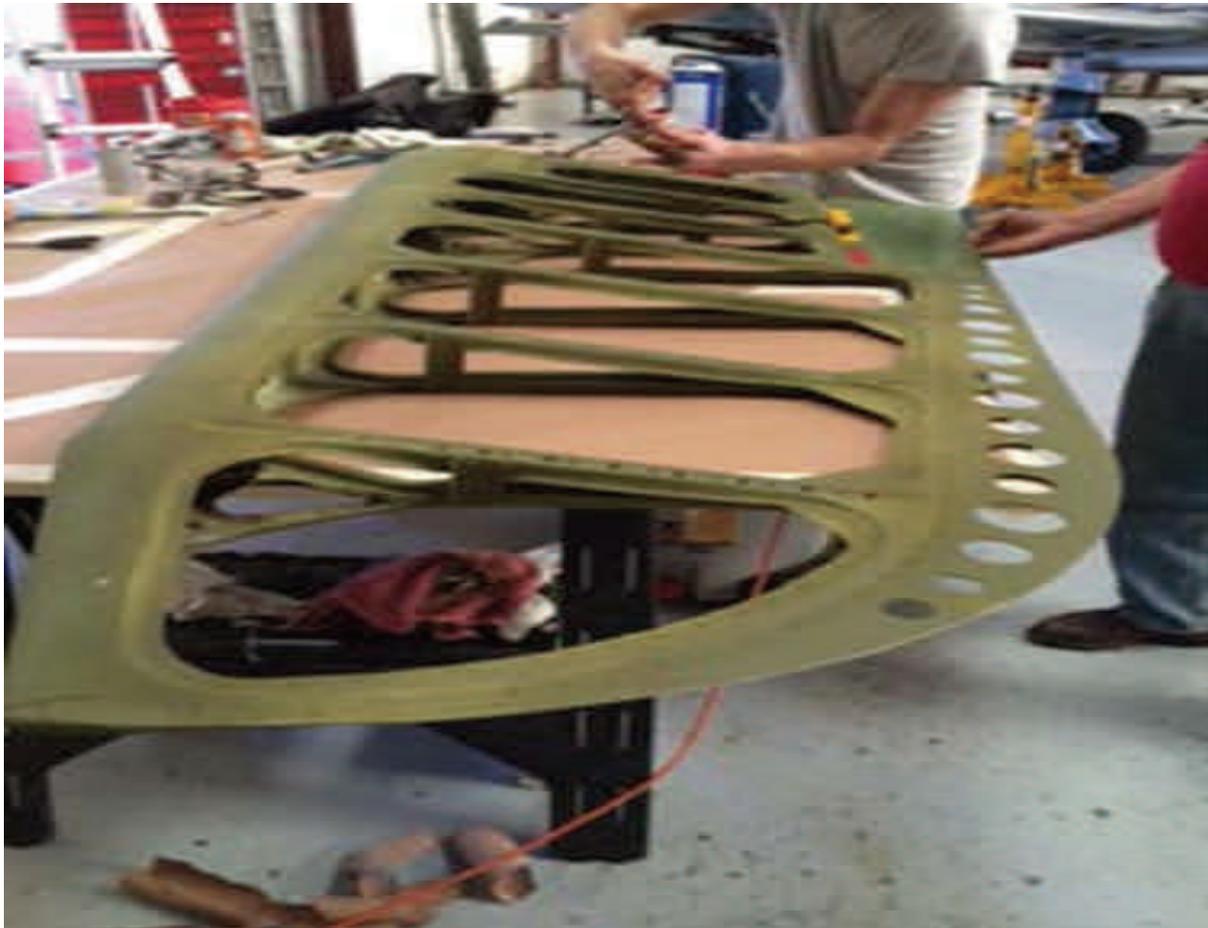
While viewing the rudder of the Kate, we noticed that the plan form of the rudder has been exaggerated by an aluminum supplement to the structure of the rudder giving the rudder an expanded cord and rounded plan form at the top, more so than was the case of the original BT-13 rudder assembly. For those of you who have not spent time looking at the Kate, the fuselage was stretched nine feet by a six foot plug in the aft fuselage and a three foot plug in the nose. Then, the leading edge structure of the wings adjacent to the fuselage was altered to give the wing the plan form of a Nakajima Type 97 Bomber. The square wingtips were removed, and rounded wingtips were installed, increasing the wingspan of the aircraft about four feet. Behind the six foot plug in the back of the fuselage a BT-13 tail assembly was installed. However, the BT-13 tail was extensively modified. The leading edge of the vertical stabilizer was moved forward to give it the plan form of a Nakajima Type 97 Bomber. And similarly, the rudder plan form was altered as well, all for cosmetic purposes. With the flight controls removed and the fabric removed, the alterations made on behalf of 20th Century Fox become more apparent.
